Toronto Union Station

Fifth Façade Conservation

Roofscape and Skylights

October 3, 2014

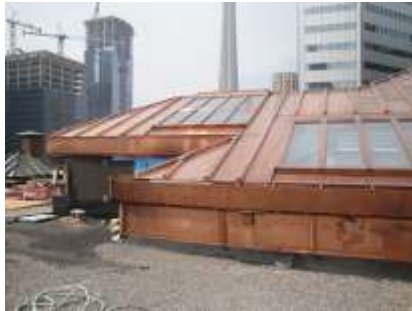
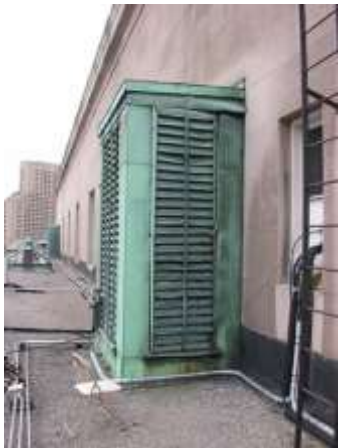
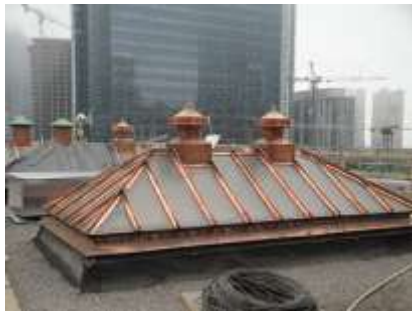
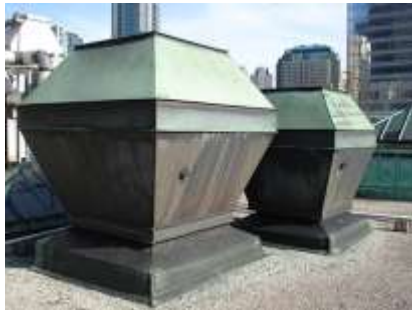
Fifth Façade, West Wing & Centre Block (East Wing current):

- Copper Roofs;
- Flat Roofs;
- Skylights;
- Copper Roof-top Enclosures;
- Roof Penetrations and Drainage;
- Mechanical/Electrical Systems;
- Building Maintenance & Safety.

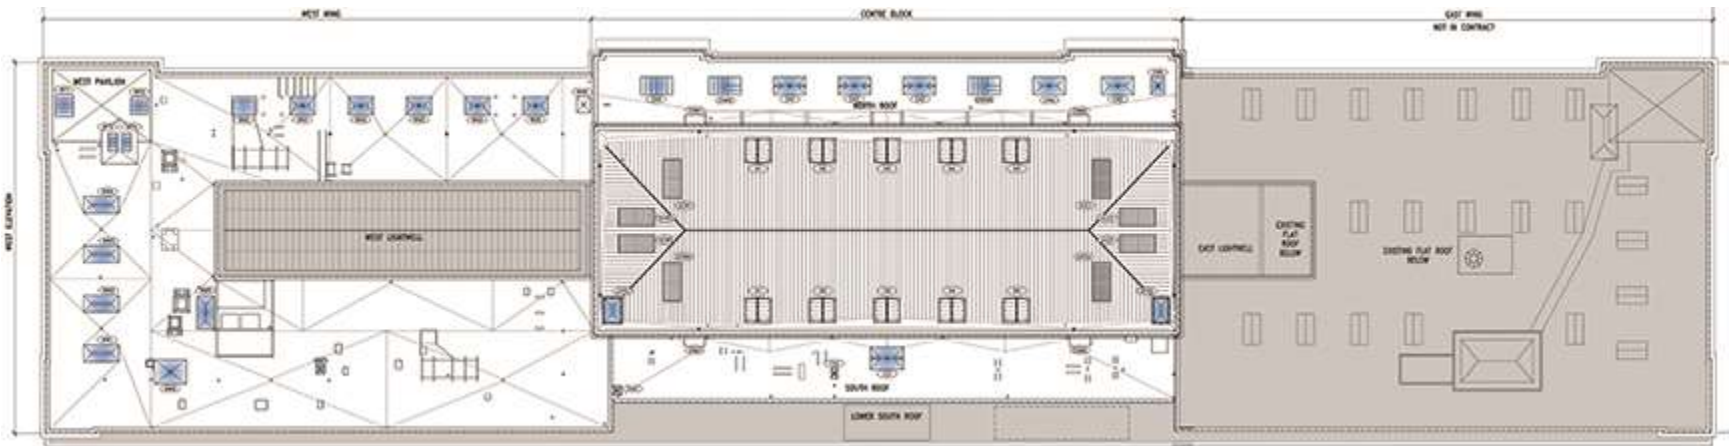
Skylights: 29 in total:

- Served as natural light to the 4th floor;
- Mid-level roof construction blocked exterior walls at 4th floor level;
- Laylite at interior ceiling levels diffused the natural light into the office spaces.

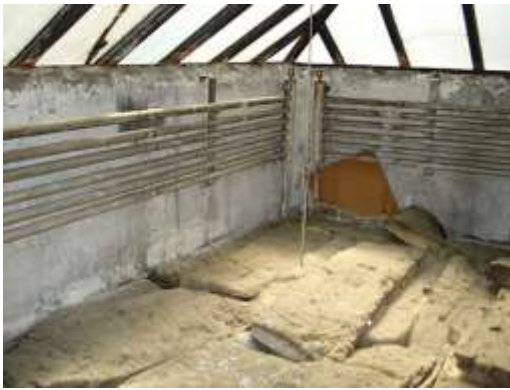
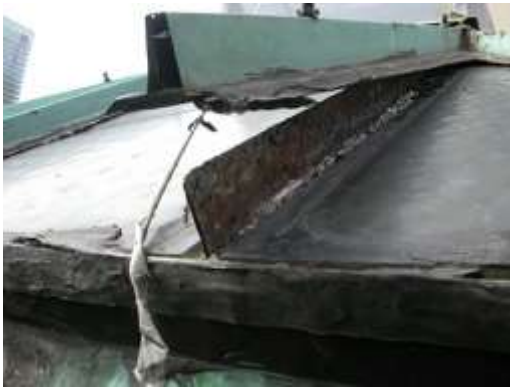
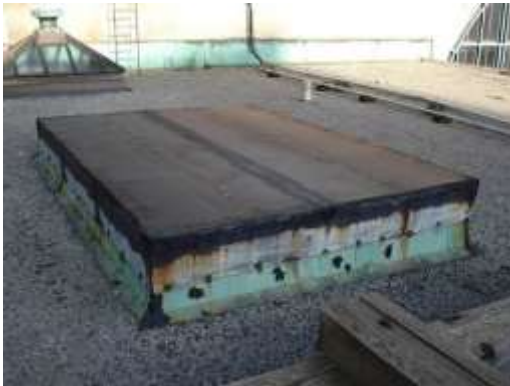
Union Station Existing Conditions summary

- Extensive oxidization, wear and tear of exposed copper surfaces;
- Cap flashings, glass stops and soldered connections have failed;
- Mild steel sub-frame system extensively corroded and damaged;
- Extensive damage of glass units;
- Some deterioration of masonry parapet walls and curbs;
- Skylights structural integrity is compromised.

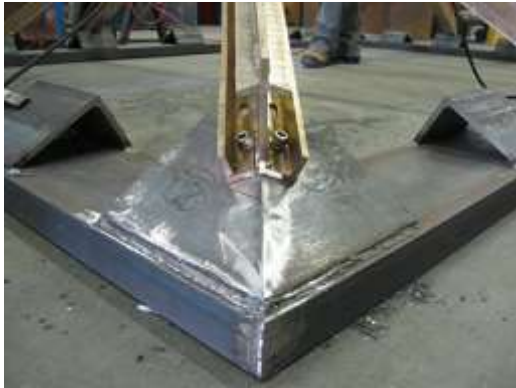
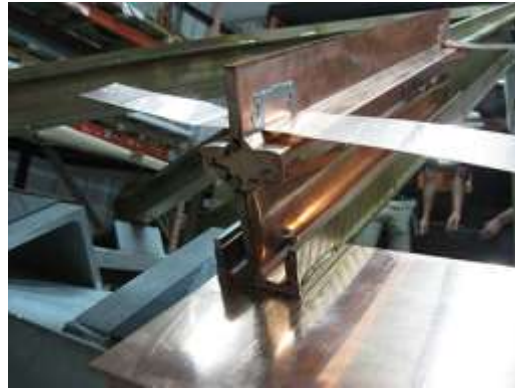
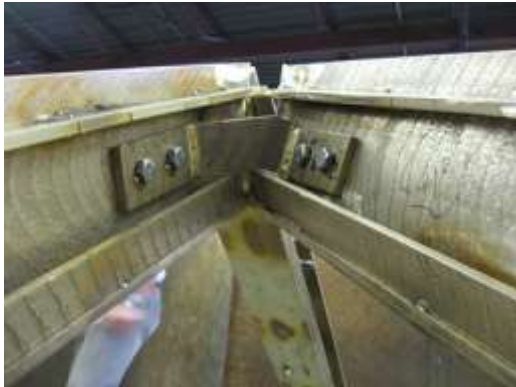
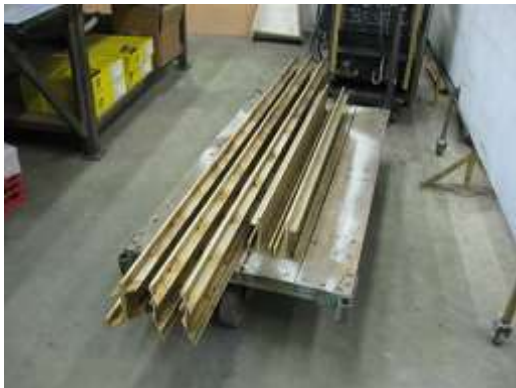
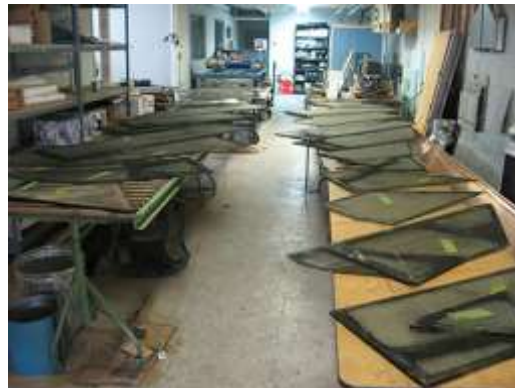
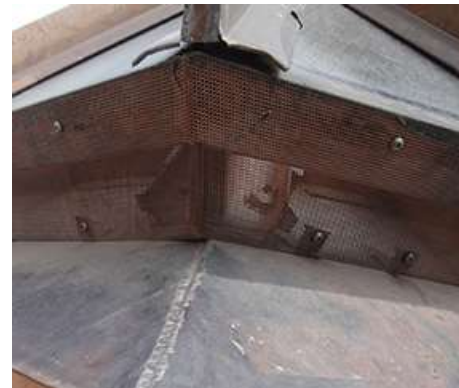
Union Station Fabrication shop issues

- Base frame and pads;
- Structural welds and lateral stability;
- Copper cladding joinery;
- Copper cap holdowns;
- Vent screens;
- Glass reclamation.
